The Toughest Weld of All

Half mile of delicately fused metal unites panels of thin-skinned Saturn S-II, second stage of moon vehicle

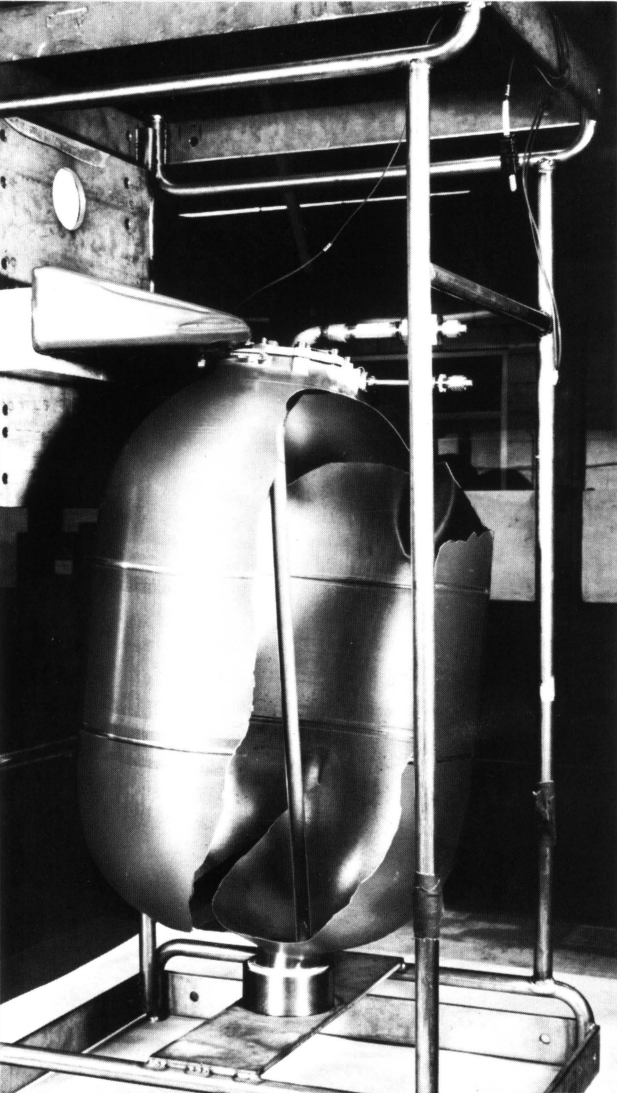
Mysterious rupture of Apollo titanium propellant tank, left, launched eight-month stress corrosion investigation by North American Rockwell, Bell Aerosystems, NASA Manned Space Flight Center. Reliable flight operational tanks, bottom, have profited by solution.

A small titanium tank containing nitrogen tetroxide suddenly ruptured in the course of normal test. Other tanks began to burst. The ruptures launched a massive eight-month investigation that called on the highest corrosion talent at Bell Aerosystems, at the NASA Houston headquarters, and at North American Rockwell's Space Division and Los Angeles Division. At stake was the engineering feasibility of scores of other titanium tanks used in the moon venture. At stake was the timetable for landing on the moon.

When the mystery was solved the cause of the rupture was almost stunning in its simplicity. Inadvertently a trace of nitric oxide had been omitted by the propellant manufacturer from the nitrogen tetroxide propellant stored within the offending tanks. That one omission had meant the difference between the acceptance and rejection by the stressed titanium tank of its corrosive inhabitant.

The trace of nitric oxide was returned to the propellant, and the problem was overcome.

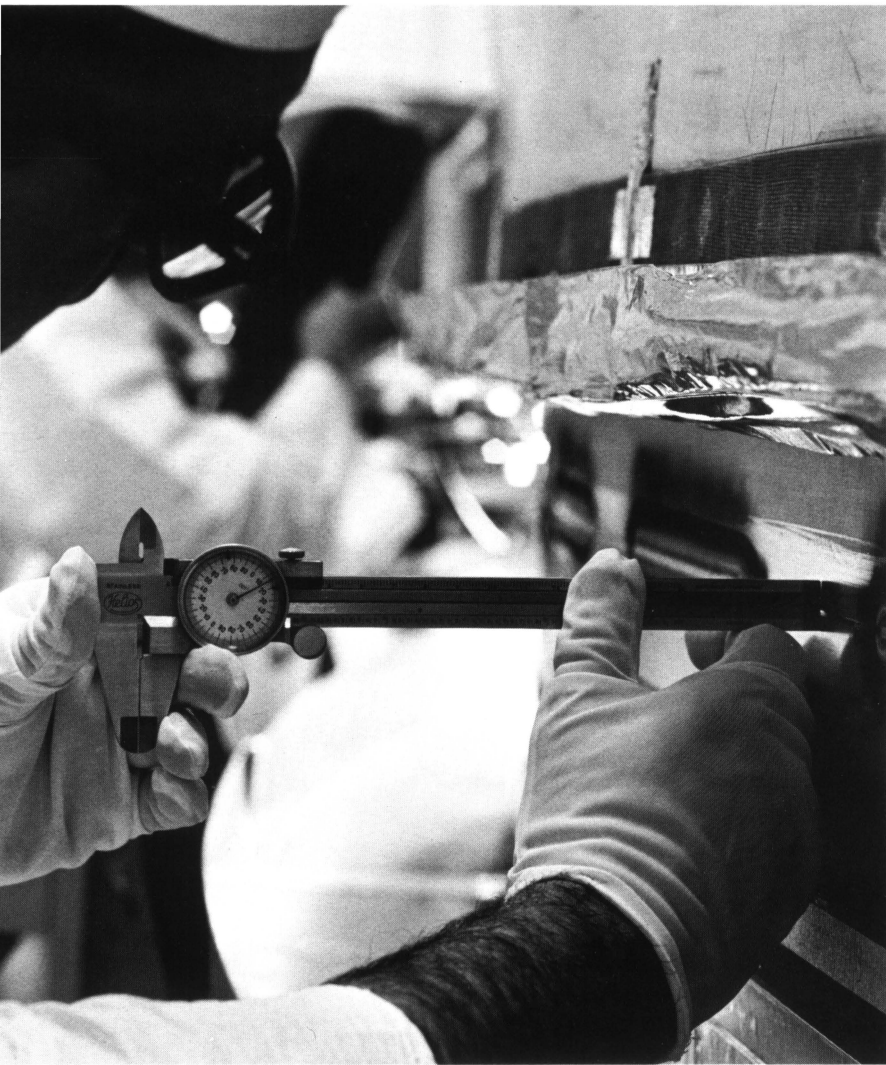
Left above, checking offset of two welded cylinders with vernier caliper is key operation. Mated cylinders must be matched to tolerances within thousands of an inch.

Next came the vexing problems of offset: how to match the bulkhead and cylinder with unerring precision, perhaps the single most critical step in the entire operation. A split-hair mismatch can cause rejection of the entire job.

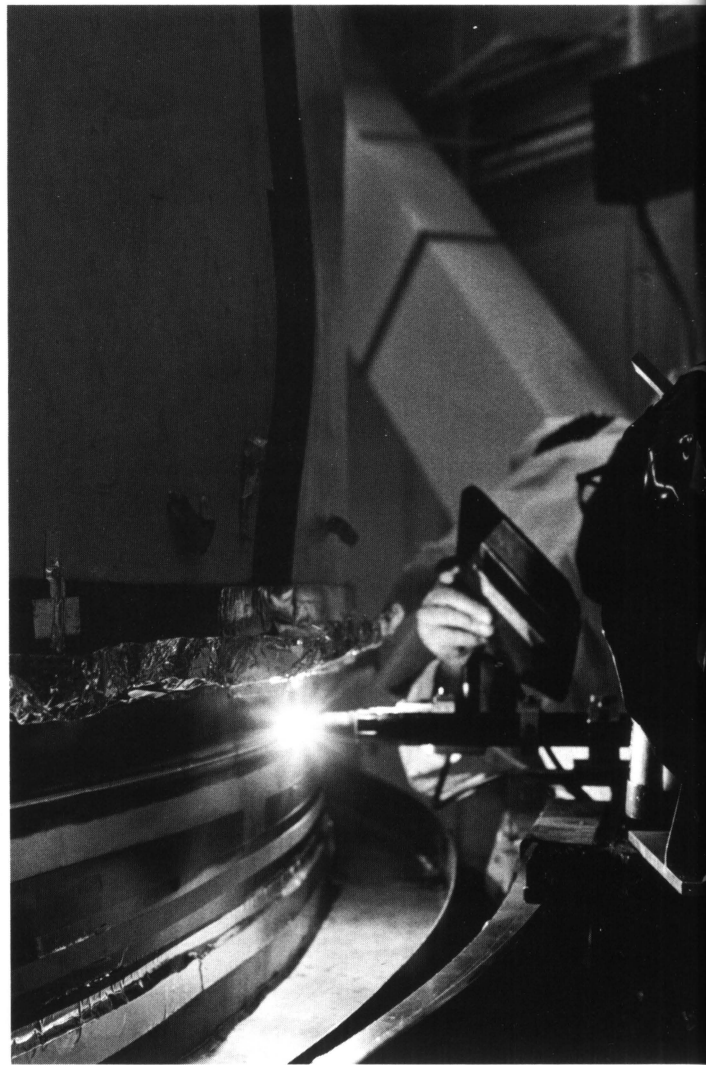
Brilliant torch light, above right, employs a tungsten electrode, generates temperatures of 3000 to 5000 degrees Fahrenheit.

rent TIG (tungsten inert gas) welding method is used. That is, the welding torch, which generates between 3000 and 5000 degree F. heat, uses a tungsten electrode. Inert gas (helium) is used to shield the molten metals being fused from atmospheric contamination.

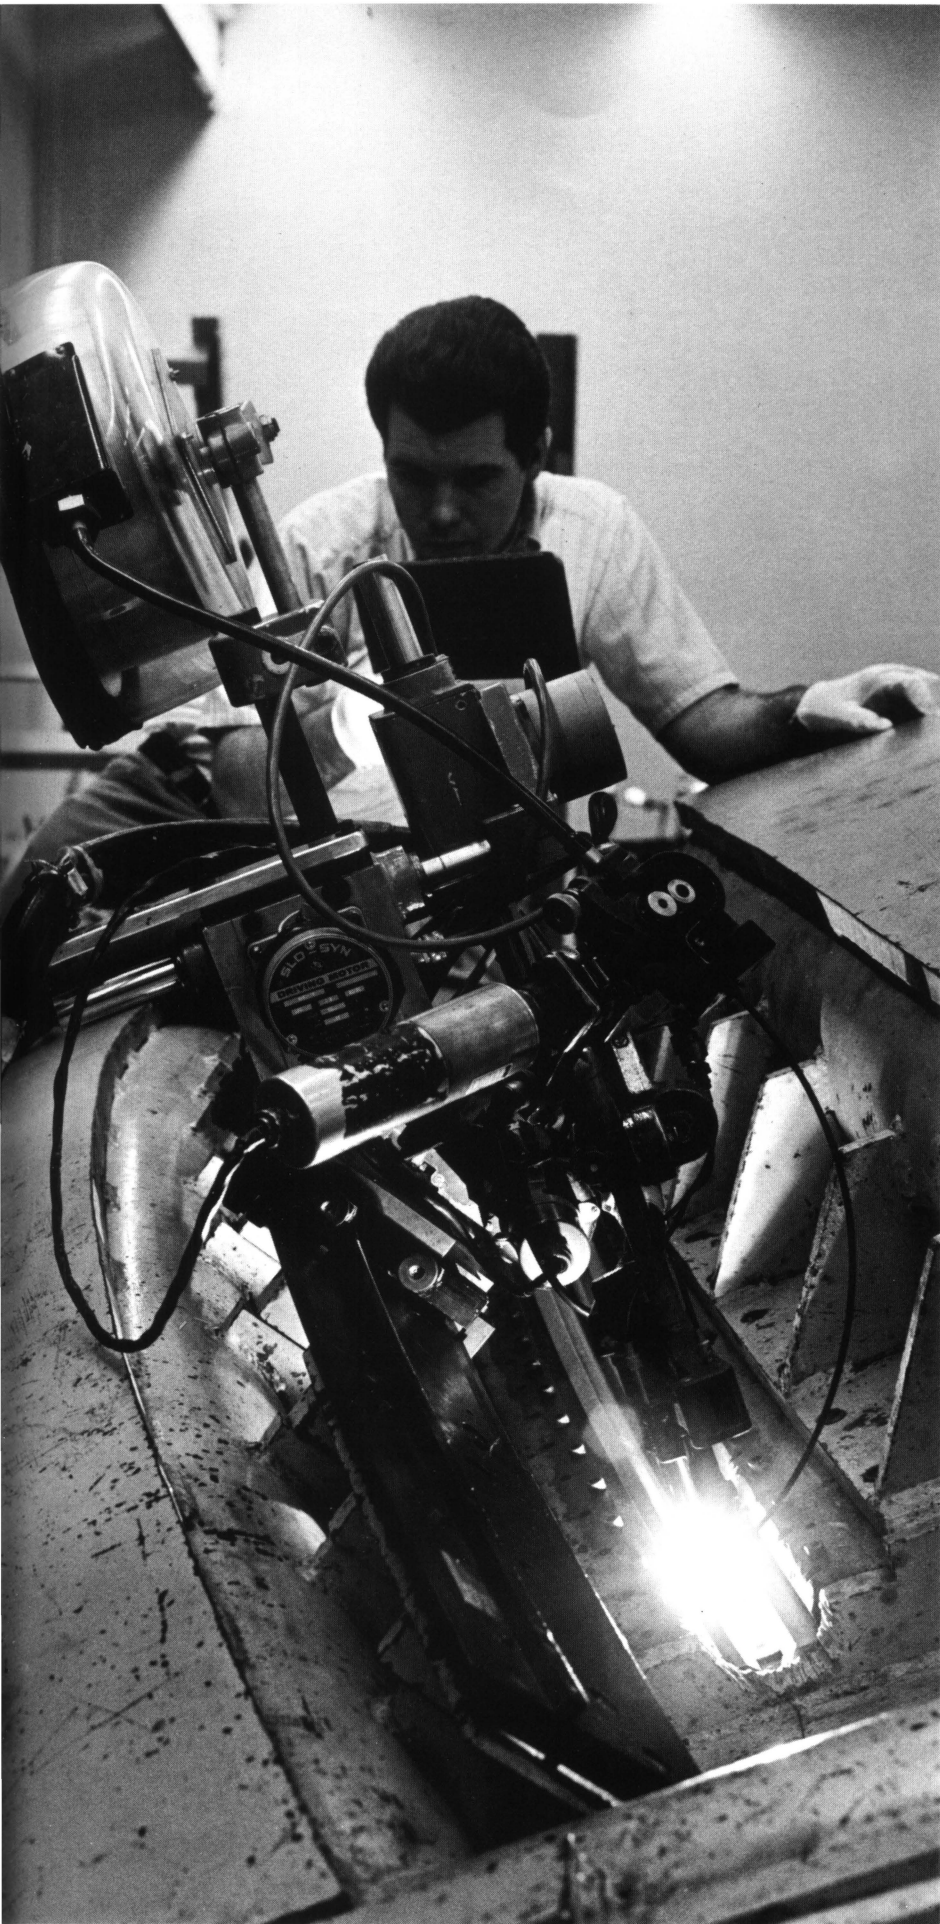
Intermediate bulkhead panels are welded to thicker, waffled outboard panels, right, at L.A. Division, then sent to Seal Beach.

The Saturn V second stage is made of dozens of panels and frames, which, joined together, become cylinders and bulkheads, and ultimately full-size tanks. Some of the work begins at the Los Angeles Division. Here, intermediate bulkhead panels are welded to thicker, waffled outboard panels, and are sent to Seal Beach. There are a dozen panels for each bulkhead and they are joined, two at a time. Picture sections of an orange that are regrouped and you have a fair idea of how the operation works. Bulkhead panels are called gore sections, and they are clamped vise-like into a fixed position by a clamshell beam. The welding torch is mounted on a skate track on the outside of the structure. Like a miniature locomotive moving at a precise, geared speed, it rides upward, 12 to 20 feet, uniting the two pieces of metal by heating them to a melting temperature that causes fusion. This is called meridian welding. The ingenious skate, which moves vertically or horizontally, on straight lines or around curves, trims, welds and x-rays in sequence as it goes.

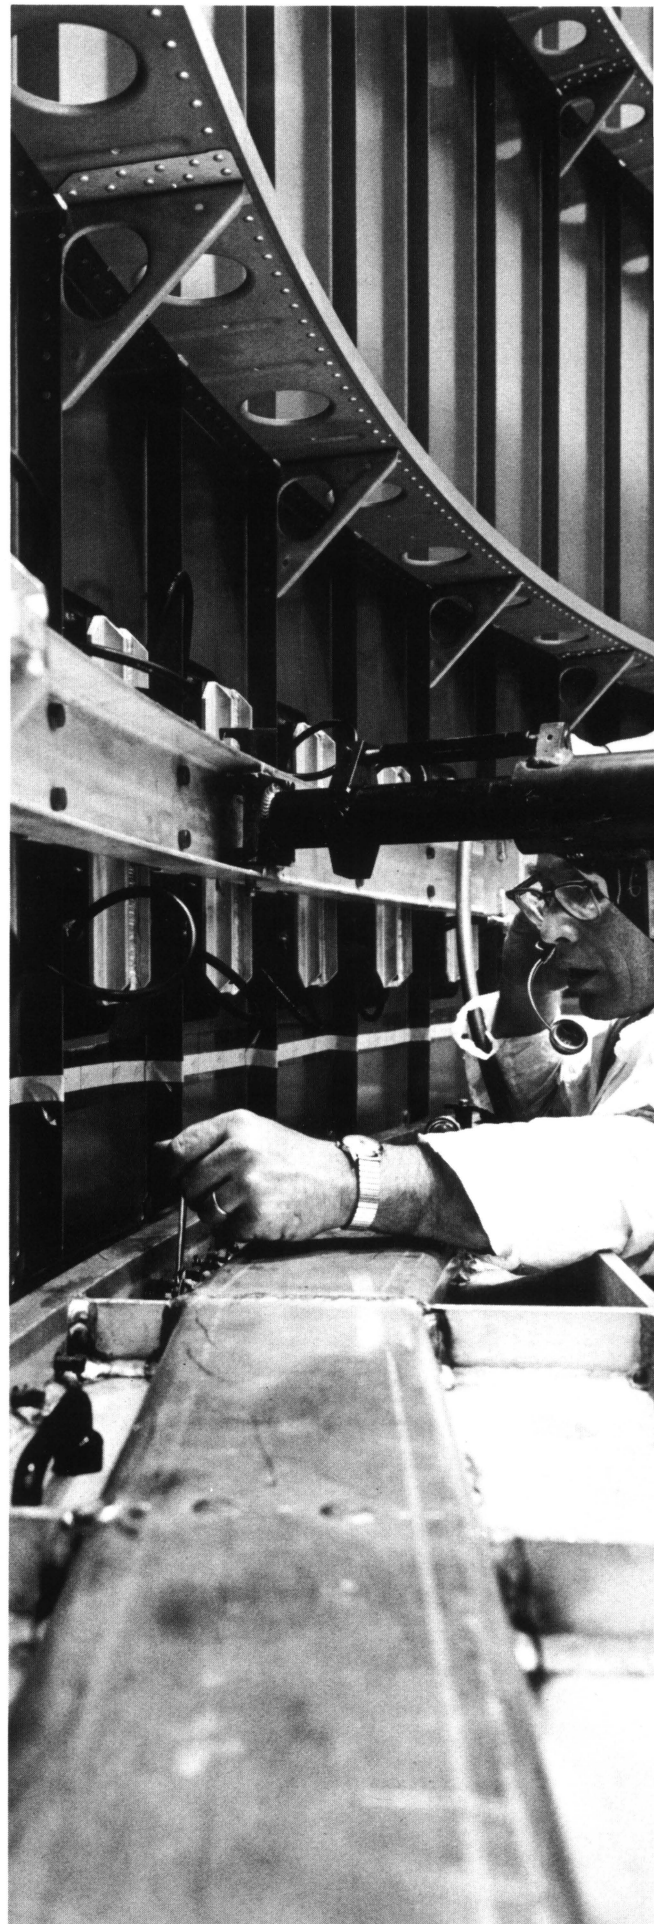
To match cylinders within thousands of an inch, backup bars, far right, were redesigned with a built-in flexibility. Spaced screws can be alternately tightened or loosened until the cylinders mesh perfectly.

The solution? Backup bars which are placed inside the stage during the alignment process were redesigned with individual screws spaced every few inches, thus giving the bars a built-in adjustability. The screws can be alternately tightened or loosened until the bulkhead and cylinder mesh perfectly.

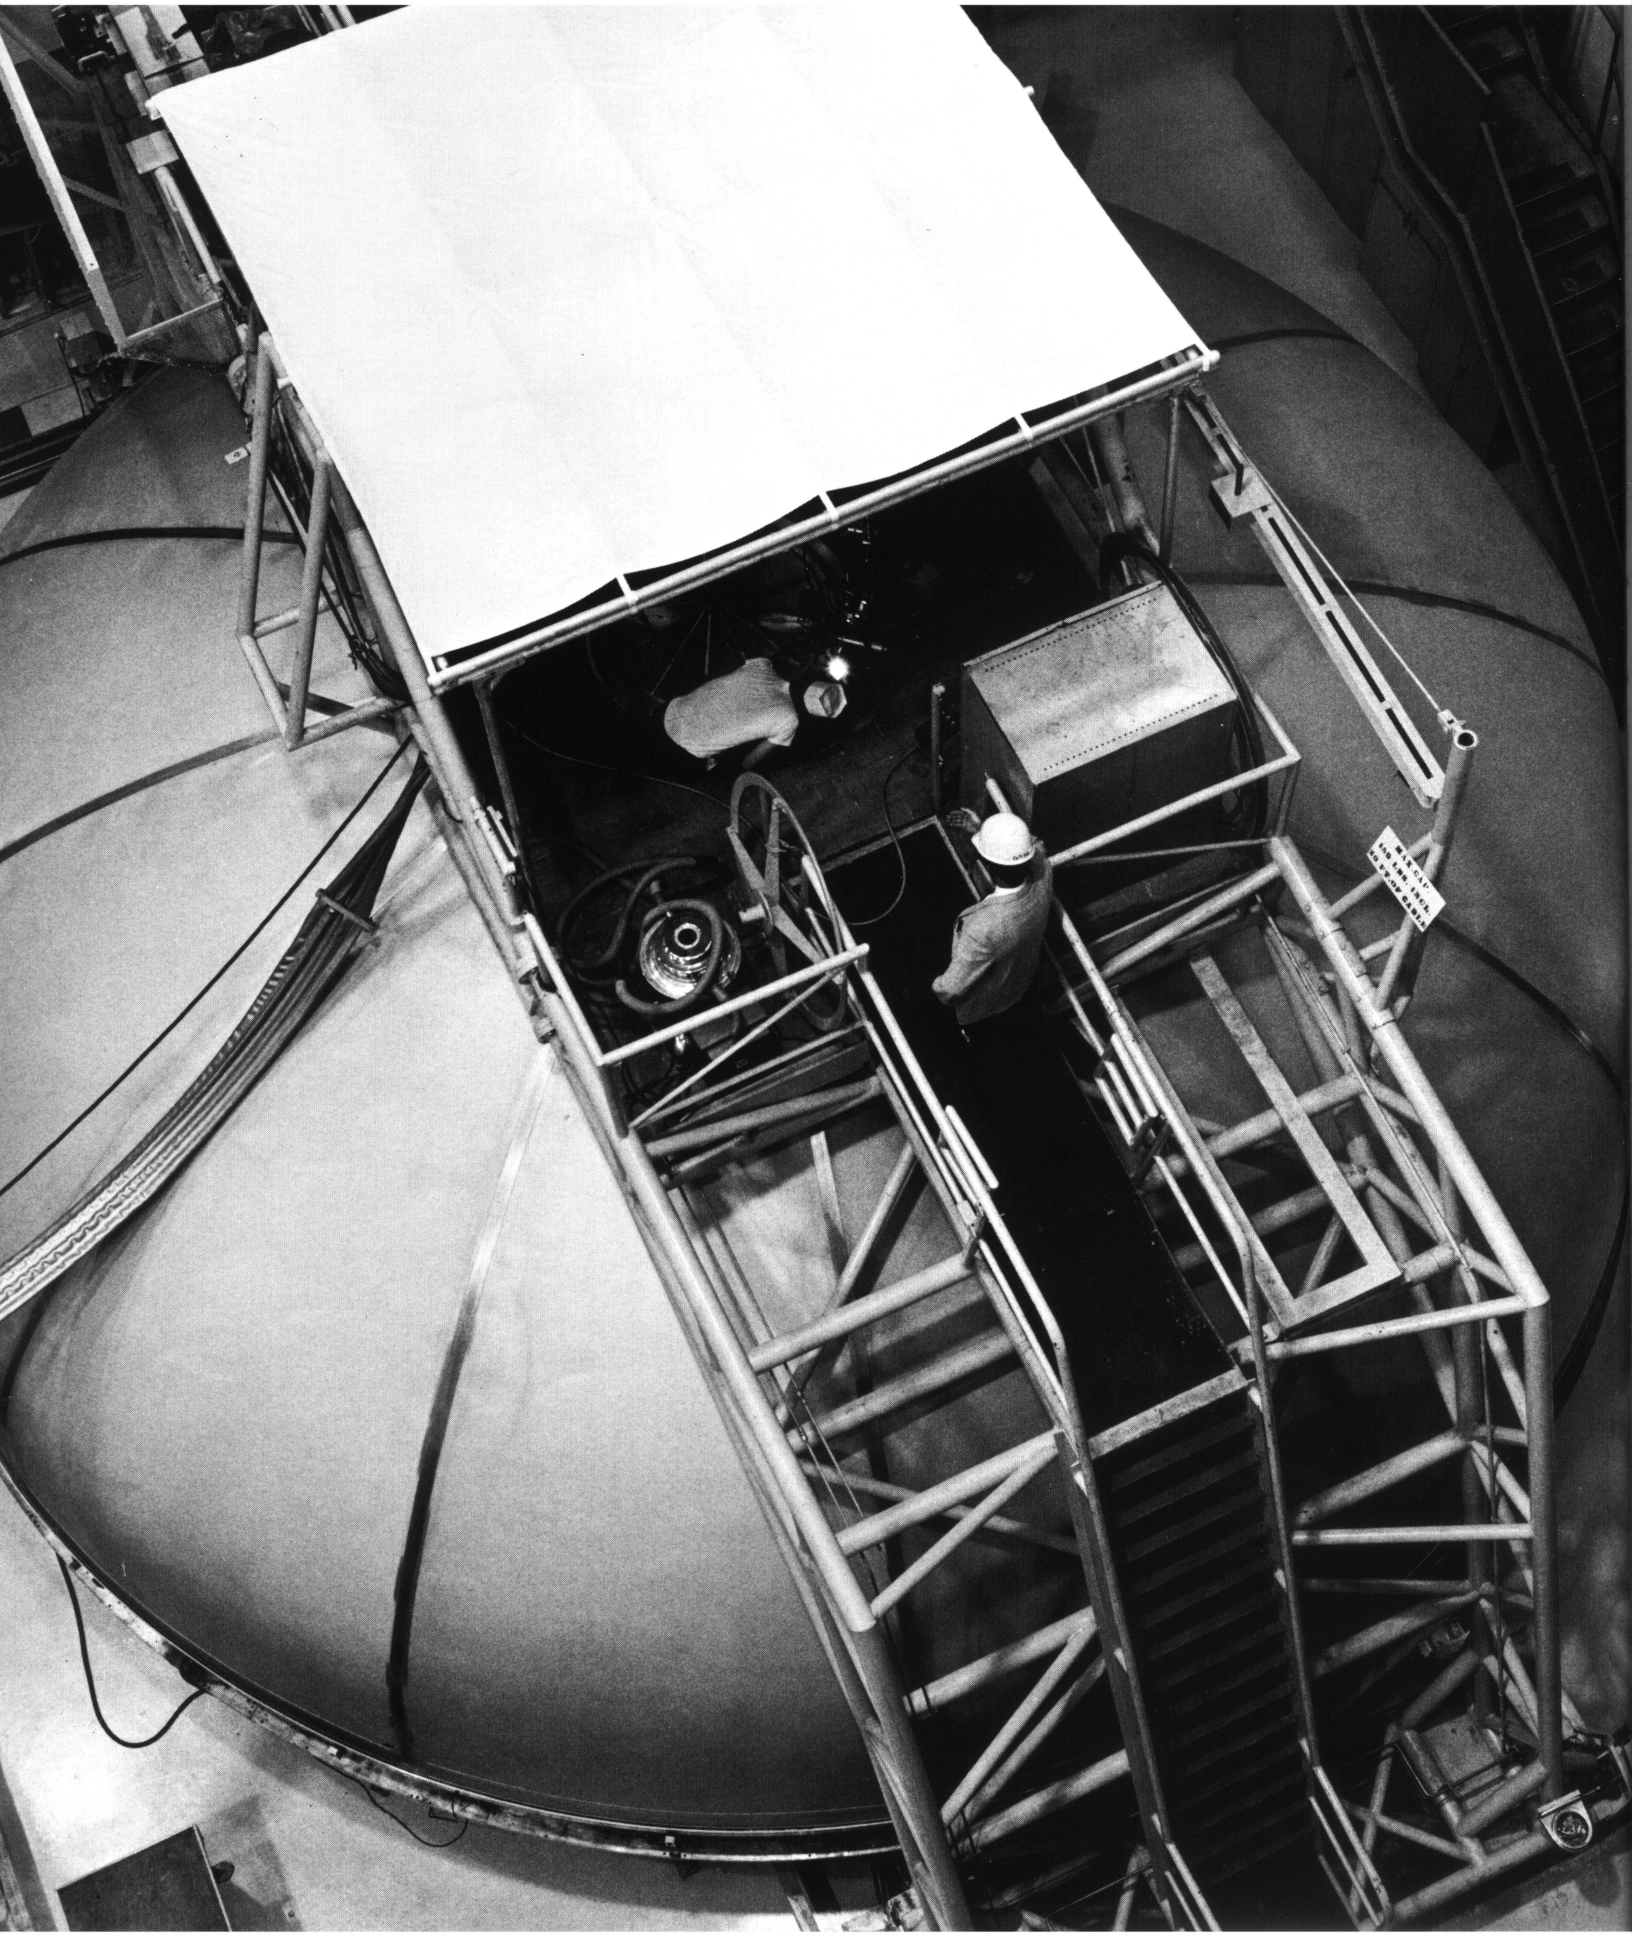
After 12 bulkhead panels have been joined, opening under the canopy, left, called the "dollar section," is then welded into place.

By design, there is a hole left at the top of each bulkhead after all gores have been joined. The opening is closed out by a round "dollar" section, and it once caused a knotty problem. Early dollars were approximately three feet in diameter, and were welded without difficulty by holding the bulkhead and the dollar in place with vacuum chucks and hard tooling. The vacuum chucks literally suck the aluminum

To circumvent this, engineers devised a way to minimize the torch heat on this particular weld. They did it by linking two opposed nugget welds. Instead of making one weld all the way through, they drove two of them three quarters of the way into the material, first one from the top, and then the other from the bottom — and joined them, like hooking together two croquet wickets. This cuts the heat input.
